Martensite

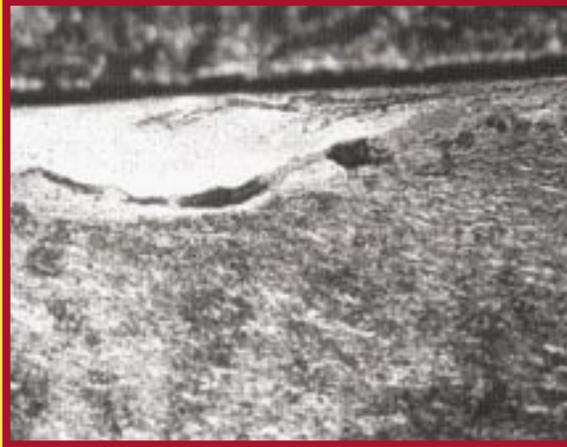
Figure 1: Photograph of the microstructure of martensitic wire. There is a heavy layer of martensite build-up, and cracks are beginning to develop.

Martensite is a brittle constituent of steel formed when the steel is heated above its critical temperature and then rapidly quenched. In wire rope, martensite occurs on the outside wire surface as a result of frictional heating on the rope surface, followed by a mass cooling effect from the cold steel beneath. Martensite is the hardest and most brittle microstructure that develops in steel and it cracks very easily.

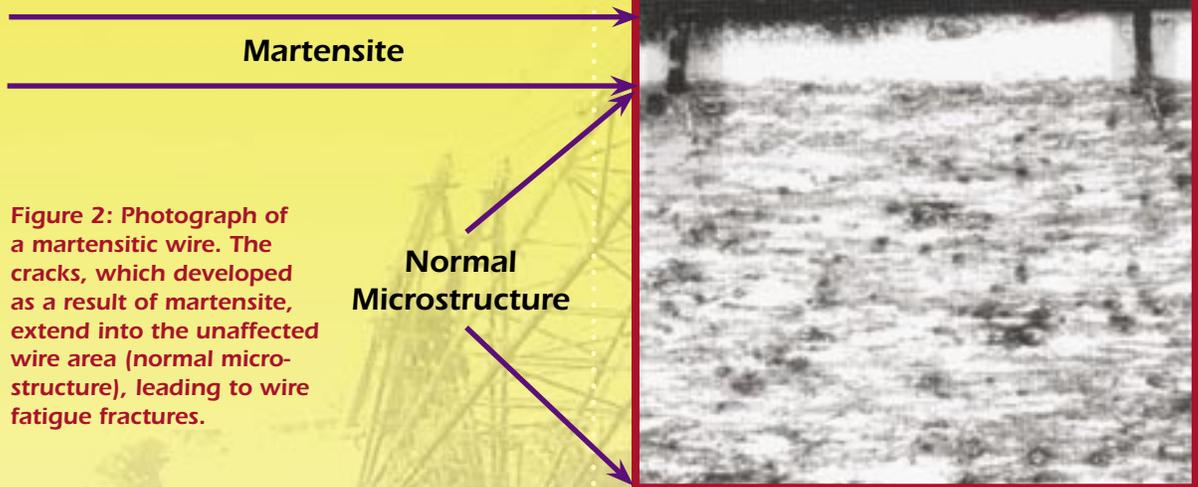
Figure 2: Photograph of a martensitic wire. The cracks, which developed as a result of martensite, extend into the unaffected wire area (normal microstructure), leading to wire fatigue fractures.

Such cracks can propagate from the martensitic wire surface throughout the entire wire. When ropes are "burned", martensite develops and can be so severe that subsequent bending will produce complete wire fractures. This explains why some ropes appear to be in excellent condition one day and deteriorating with many wire breaks the next day.

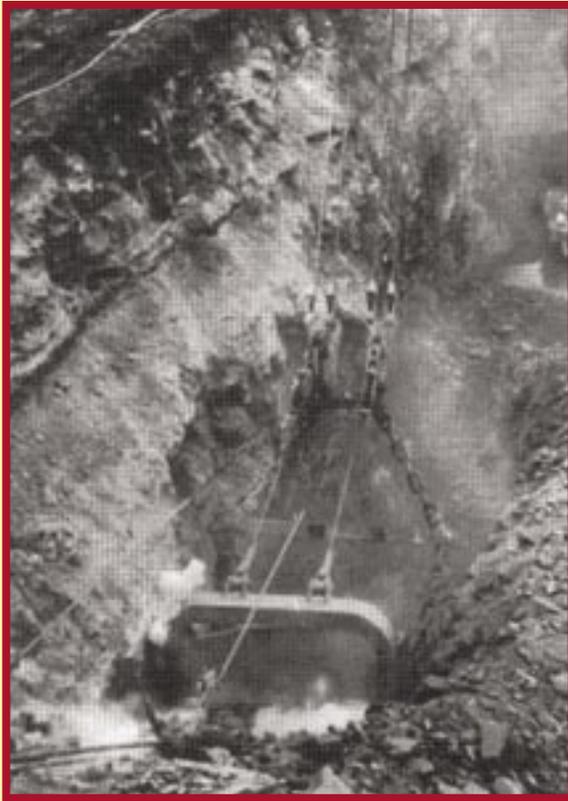
Figure 3: Burning the ropes

Surface martensite is a result of field conditions, particularly burning the rope. Burning occurs under several operating conditions.

- Martensite can develop if the drag rope is continually pulled through the roll at the front of the dragline.
- The roll must be pushed down to prevent the ropes from sawing through the dirt and rocks during bucket loading. When the ropes are pulled through the roll, burning is frequently observed as sparks flying from the ropes during operation. Some mines have gone to a double stepback from the cut to reduce walking time and increase digging time. However, this usually has a negative effect on rope service life because inevitably the ropes are pulled through the roll and burned.

- Sheaves (especially with large mass) may overspin, and under varying loads and speeds may cause martensite development on the outer rope wires.
- Tight sheaves and/or oversized ropes, especially under heavy loading conditions, may cause martensite on the rope wires as the rope is forced into the grooves. This action causes heavy friction and super heating of the wire surface followed by a quench cooling from the base metal.

- Hoist ropes are subject to martensite development if tight sheaves, sheave overspin, or ropes jumping out of the sheaves occurs as a result of operating conditions.

- Ropes rubbing against each other on the drums or against other objects such as the steel superstructure (missing or worn slap boards) will cause martensite.

- Frozen guide rollers or support sheaves will also cause increased heat from friction on the rope surface, producing martensite.

Once martensite is produced in a rope, there is no corrective action to reverse its effect on wire breakage. Wires will fatigue and break at a higher than normal rate, resulting in short service life for the ropes. Therefore, it is most important to avoid burning the ropes if the best rope performance is desired.
