# Mining Rope Inspection

**Wire Rope Works, Inc.**

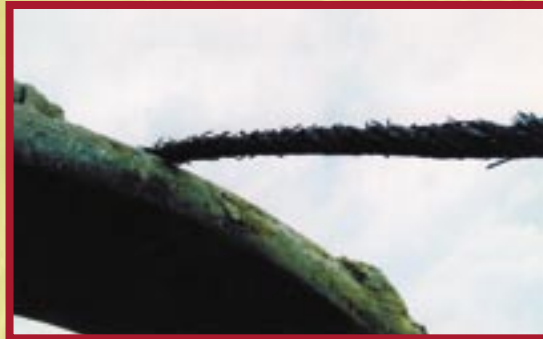
Figure 1: This dump rope shows severe abrasion.

Abrasion damage may occur when the rope contacts an abrasive medium, or simply when it passes over the drum and sheaves. Therefore it is vital that all components be in proper working order and of the appropriate diameter for the rope. A badly corrugated sheave or drum will seriously damage a new rope, resulting in premature rope replacement. Refer to Bethlehem Wire Rope® Mining Technical Bulletin 2 on Sheaves and Drums for further information.

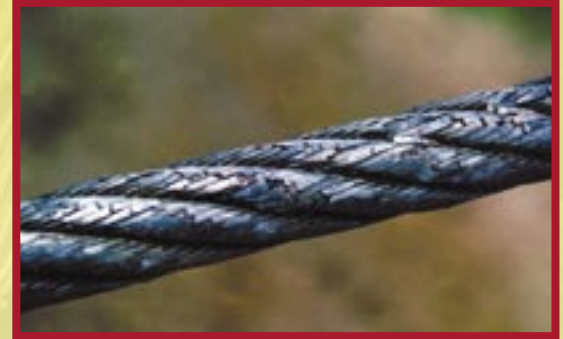
Figure 3: Worn drag rope with multiple crown and valley breaks.

Crown breaks, as shown in Figure 3, are signs of normal deterioration, but valley breaks indicate an abnormal condition such as unusual deterioration or unusually heavy rope loading. In hoist applications, valley breaks require close observation. If several valley breaks are discovered in an isolated region, this area should be marked and watched. If, however, a series of valley breaks occurs over a long length of rope, such as 40 feet or so, an inspection should be made to determine the cause. At this time the mine should plan for a change-out, particularly if rope stretching or corkscrewing occurs. Drag ropes, on the other hand, suffer from an extreme amount of wire breakage due to the very nature of their application. It is for this reason that many mines choose to run drag ropes to destruction, or at the very least beyond recognition.

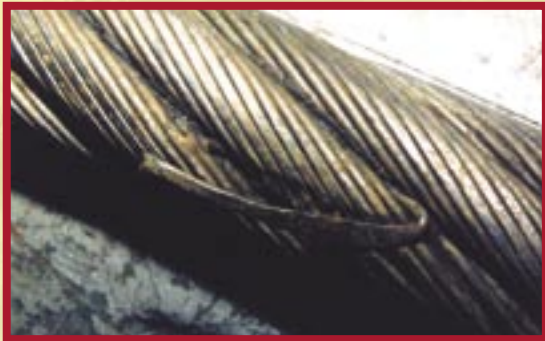
**Figure 4: Damage from untrimmed broken wires was the cause of retirement in this rope.**

Once crown and valley breaks appear, their number will steadily and quickly increase as time goes on. Remove broken wires, such as that shown in Figure 4, as soon as possible by bending the broken ends back and forth with a pair of pliers. In this way, the wire is more likely to break inside the rope where the ends will be tucked away. If the broken wires are not removed, they may cause further damage.
